Manhole Inspection Summary

Manhole # S04YY1005MH

Location Address: **3809 CLARKS LN**

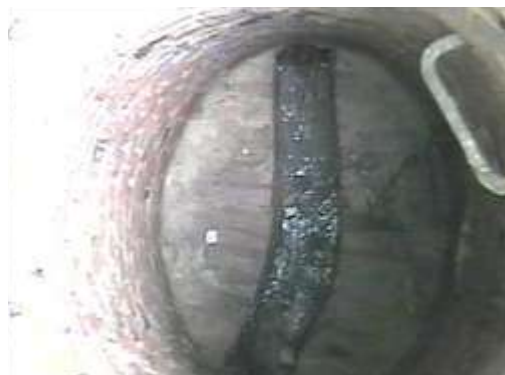
Top View

Adjustment infiltration. Evidence of surcharge - Bench debris.

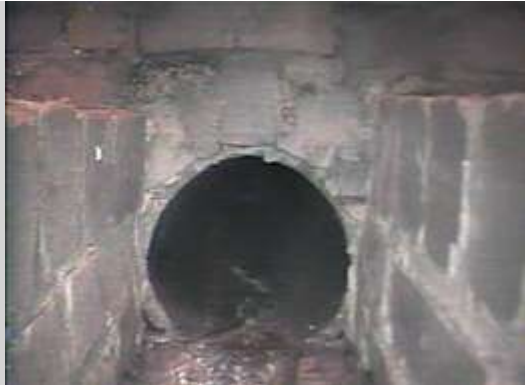
8 in. Circular Gravity Sewer Pipe Out @ 12 O'Clock

Barrel deterioration and infiltration. Channel deterioration.

Infiltration: **Evidence** Pipe Seal Cond: **Unknown**

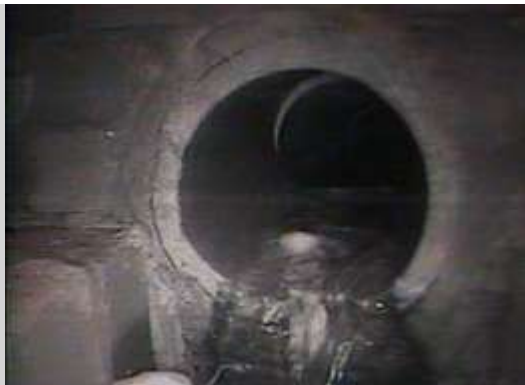
6 in. Circular Gravity Sewer Pipe In @ 7 O'Clock

Deposits: ☐ None ☐ Mud ☐ Sludge ☒ **Debris** ☐ Grease

Silt Depth: **0.5** (in.) Deposits Extent: **Light**
